EVALUATION NOTE

## STORKS, POWER LINES AND FIRE RISK

**The events in Küçükçekmece call for a reassessment of how we manage the risks that electrical infrastructure poses to birds and ecosystems.**

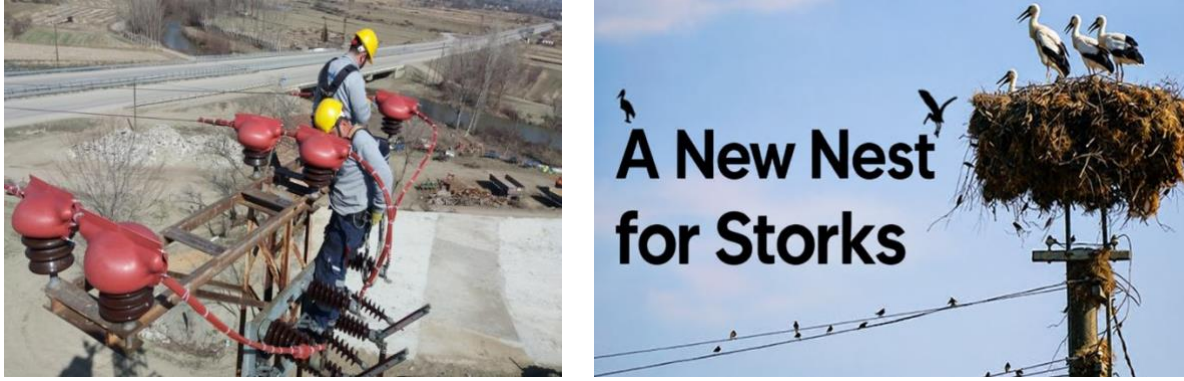
**Figure 3. Insulation measures and a safe nesting platform to reduce electrocution risk**

*Note:* The image on the left illustrates the insulation of accessible energized components. The image on the right shows a nest positioned on a platform at a safe distance from conductors. These images do not constitute a standard design for a specific line or a post-installation impact assessment.

Figure 2 shows line markers used to reduce collision risk, while Figure 3 presents examples of insulation measures and a safe nesting platform used to address electrocution risk.
